Hazardous Materials
Assessment Report –
Crawford Generating Station

October 2012

Crawford Generating Station 3501 South Pulaski Road Chicago, Illinois

Asbestos Survey Midwest Generation

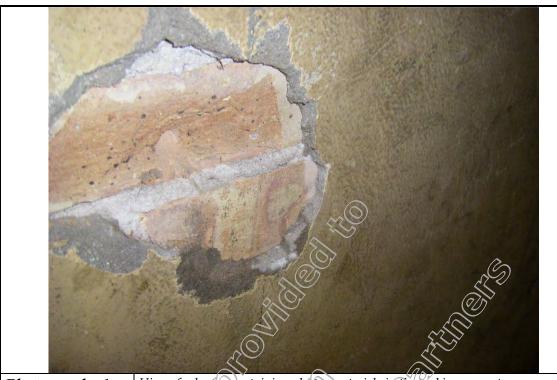
Photograph: 1 View of asbestos-containing plaster materials in the turbine room storage area

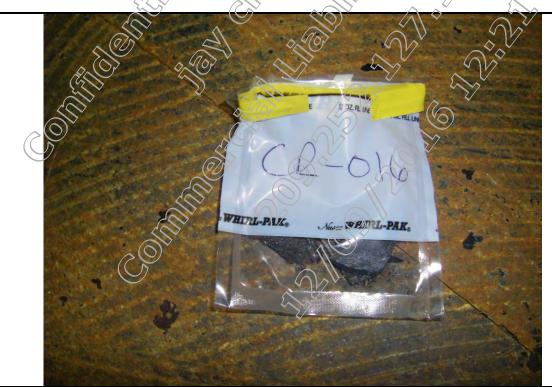
Photograph: 2 View of asbestos-containing 9"x9" black floor tile and mastic in the switch house

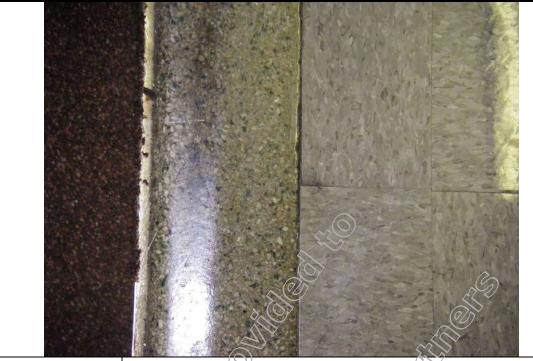
Photograph: 3 View of gray floor tile. Asbestos-containing mastic is beneath the tile.

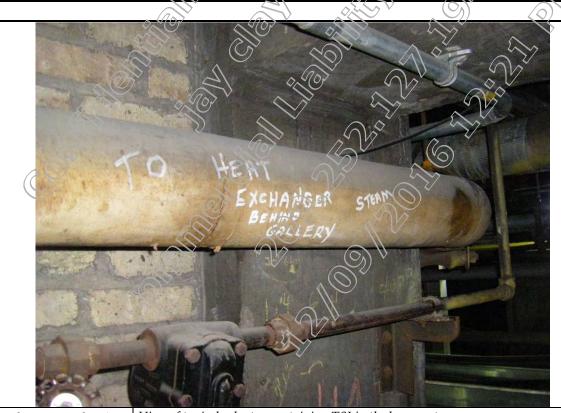
Photograph: 4 View of typical asbestos-containing TSI in the basement area

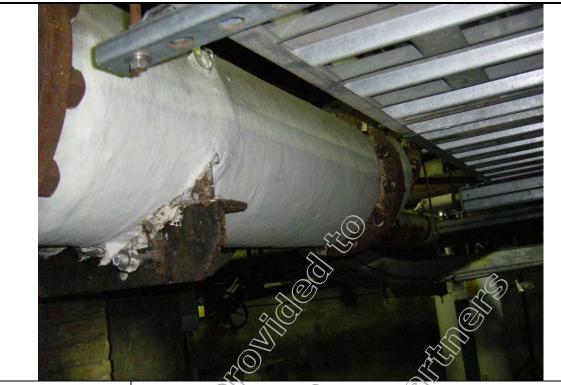
Photograph: 5 View of typical aspestos-containing TSI in the basement area

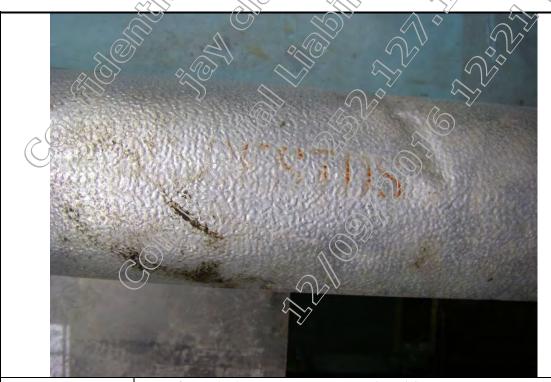
Photograph: 6 View of typical asbestos-containing TSI in the crib house

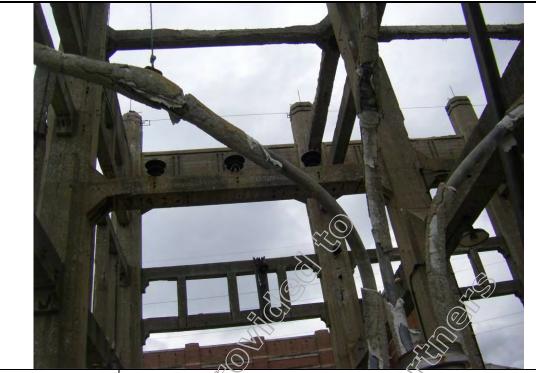
Photograph: 7 View of typical aspestos-containing TSI in an out building

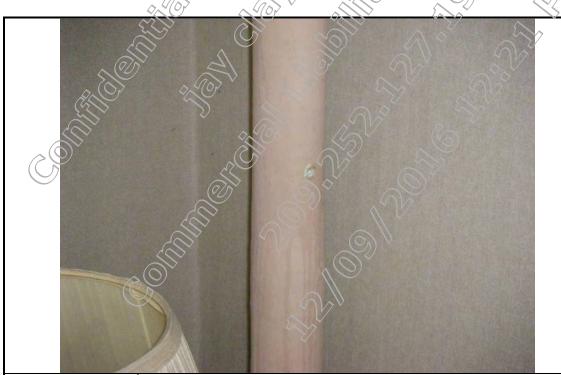
Photograph: 8 View of typical asbestos-containing TSI in the switch house

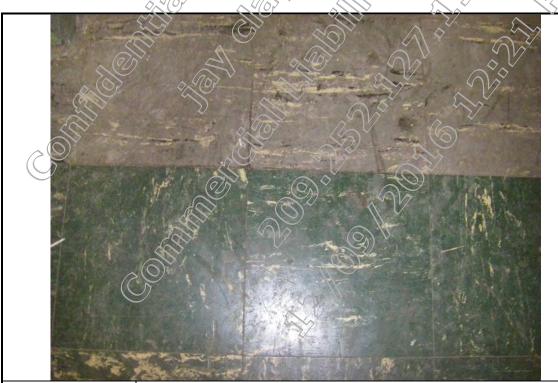
View of asbestos-containing green floor tile, gray floor tile, and associated mastic Photograph: 10 in the telecom room of the turbine room

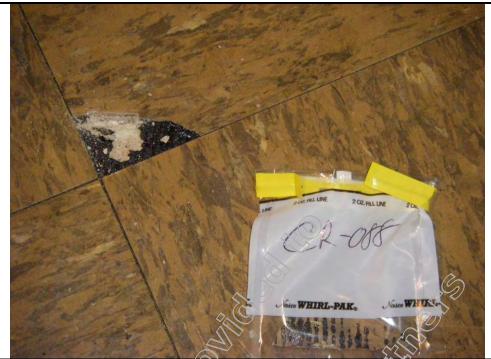
Photograph: 11 View of asbestos-containing mastic beneath dark tan floor tile in assembly room storage area on the 4th floor of the switch house

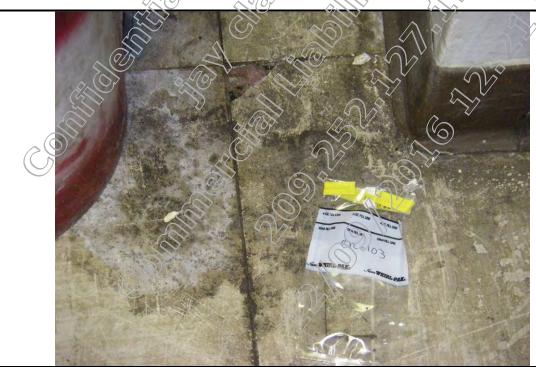
Photograph: 12 View of white floor tile with tan streaks in the 1st floor of the turbine room. Asbestos-containing mastic is below the tile

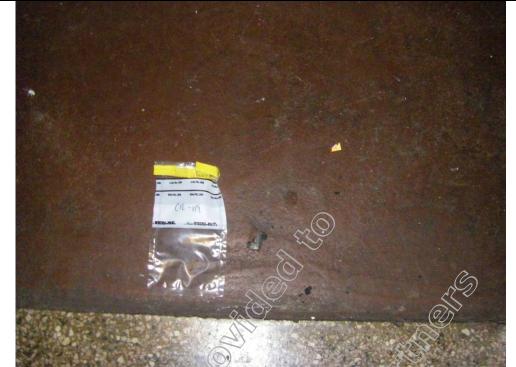
Photograph: 13 View of asbestos-containing maroon sheet flooring in Room 413 of the switch house

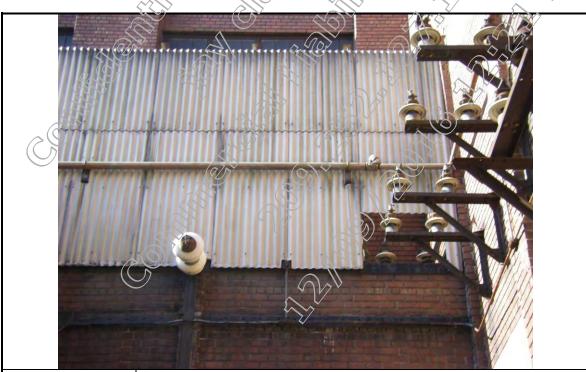
Photograph: 14 View of asbestos-containing transite materials at the main plant

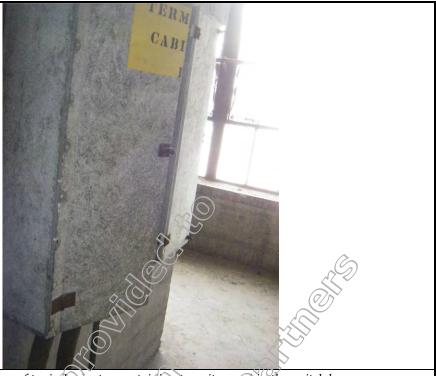
Photograph: 15 View of typical aspestos-containing transite panel in the switch house

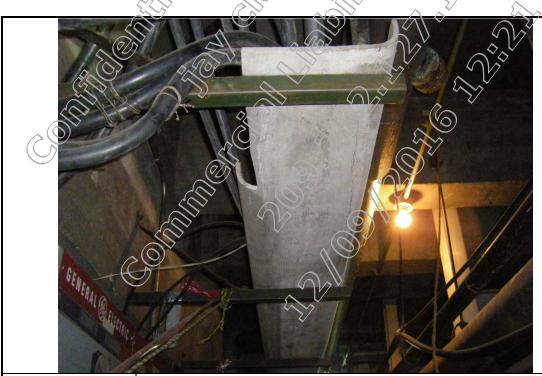
Photograph: 16 View of asbestos-containing transite material in the basement of the switch house

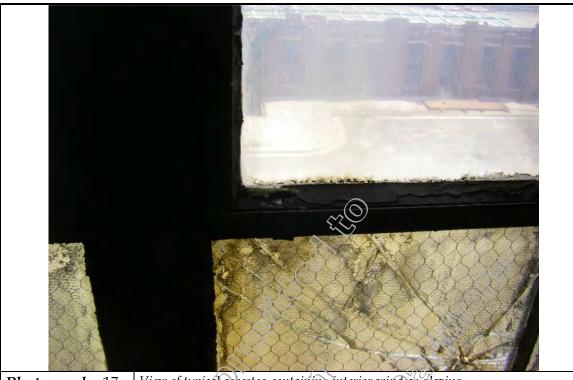
Photograph: 17 View of typical aspestos-containing interior window glazing

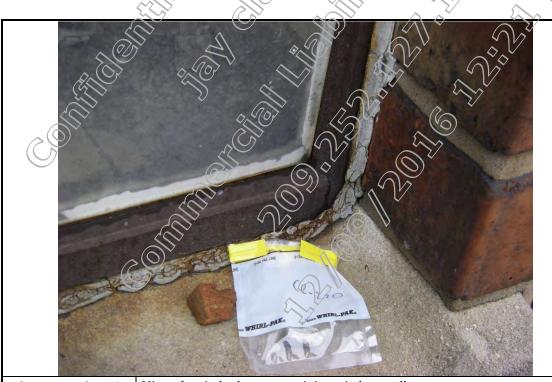
Photograph: 18 View of typical asbestos-containing window caulk

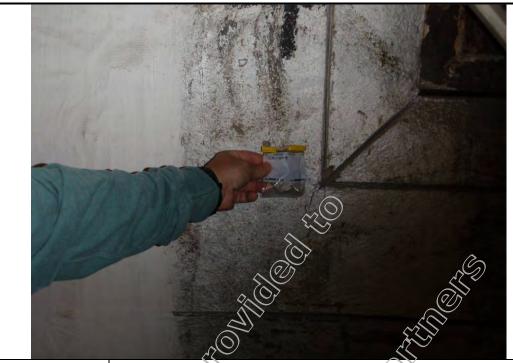
Photograph: 21 View of Boiler 778 Insulation Wrap

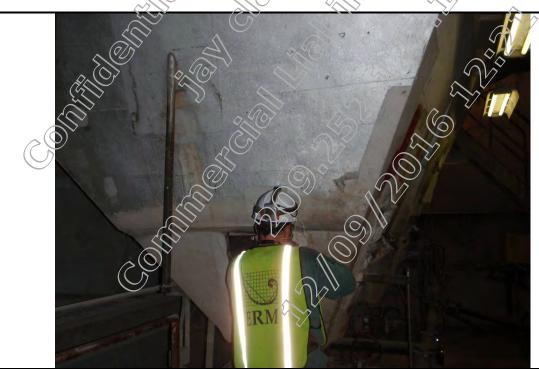
Photograph: 22 View of ash hopper insulation

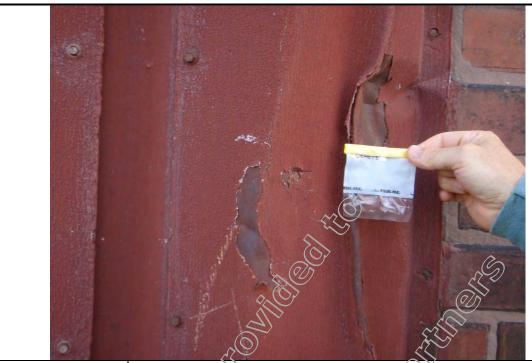
Photograph: 23 View of red galbestos on exterior

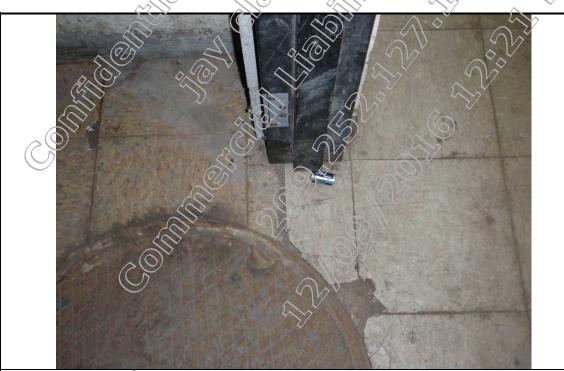
Photograph: 24 View of 12"x 12" Gray floor tile over 12"x 12" Brown floor tile
